Depositional Area

**POST-REMOVAL SITE CONTROL PLAN  
DEPOSITIONAL AREA  
TALACHE MINE TAILINGS SITE,  
ATLANTA, IDAHO**

October 2004

**MFG, INC.**

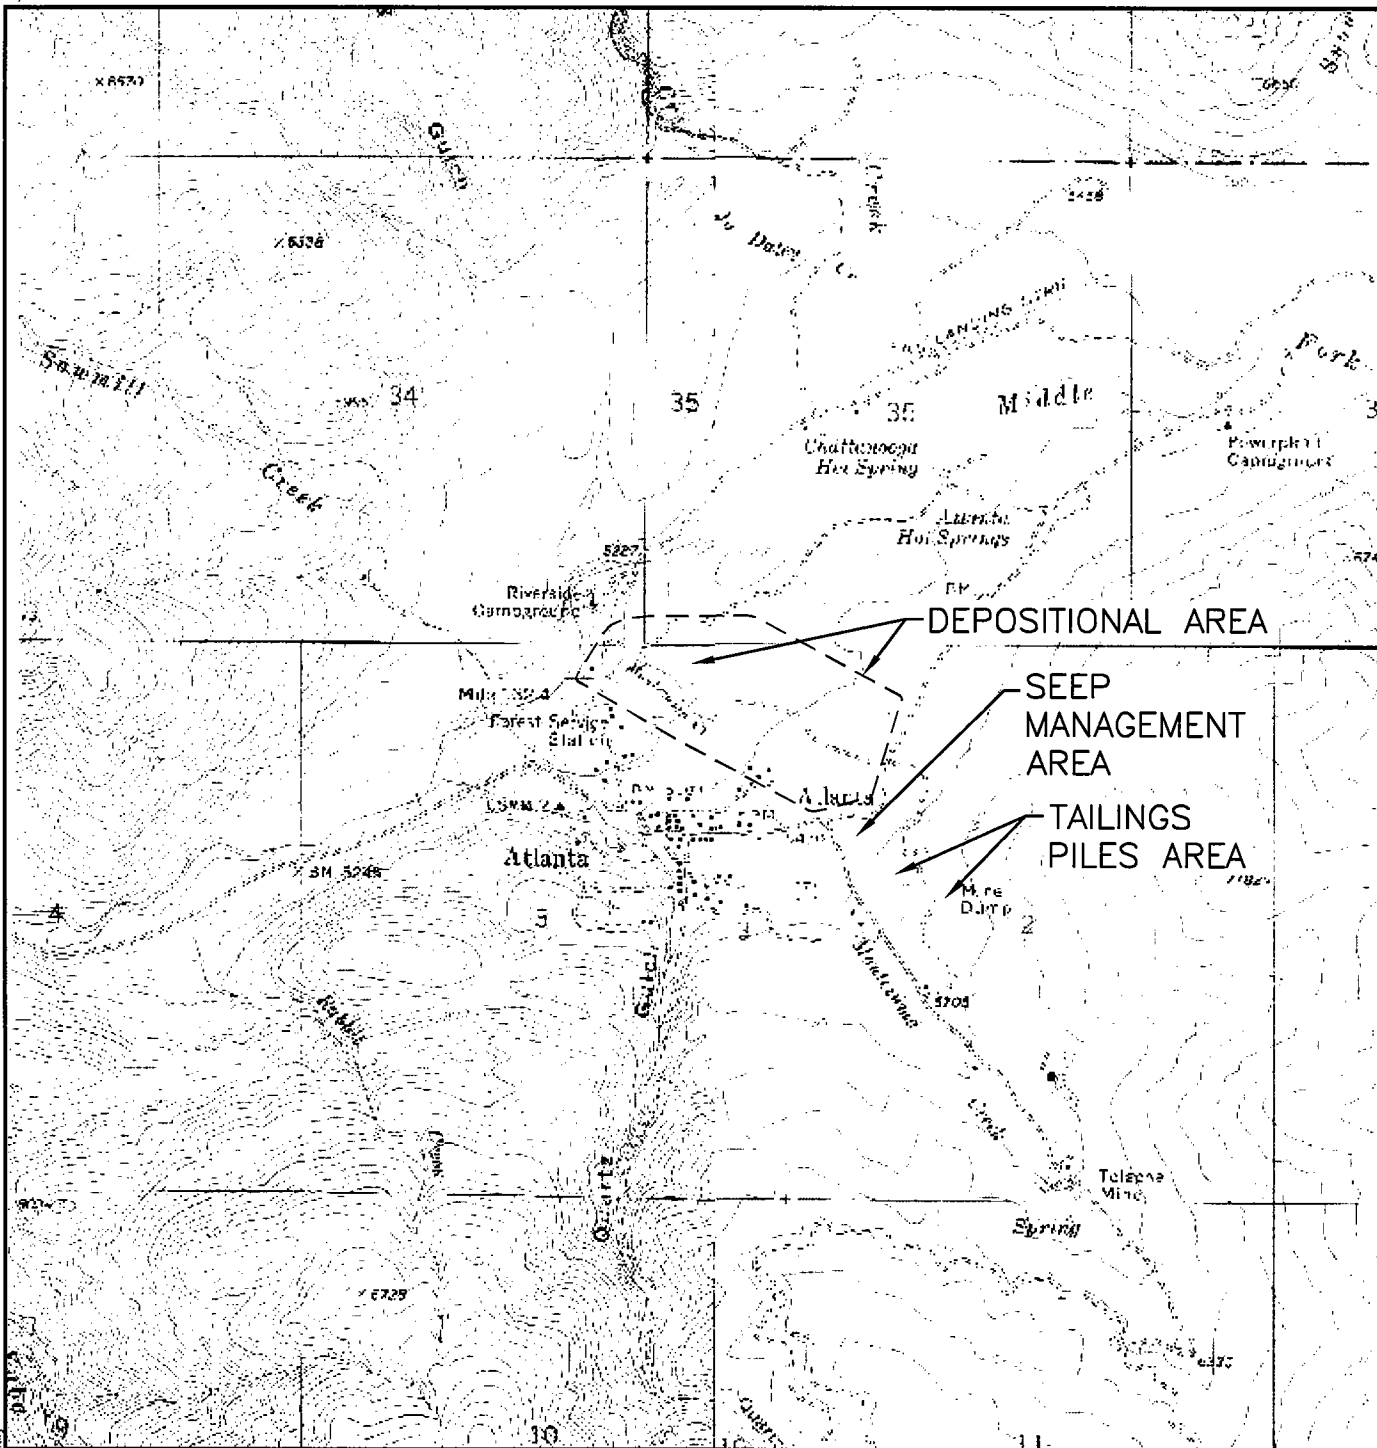
FIGURE 1

-USGS 7.5 MIN. QUADRANGLE MAP, ATLANTA WEST AND ATLANTA EAST, IDAHO, 1972.

This Post-Removal Site Control (PRSC) Plan has been prepared on behalf of the St. Joe Minerals Corporation (“St. Joe”) and Monarch Greenback, LLC (“Monarch”) for the Depositional Area of the Talache Mine Tailings Site (Site) located near Atlanta, Idaho (Figure 1). This PRSC Plan summarizes the inspection and maintenance activities for the Depositional Area as required by the Statement of Work issued by the U.S. Environmental Protection Agency (EPA, 2001). The removal action was required by the Administrative Order on Consent (AOC) for the Depositional Area (EPA, 2002).

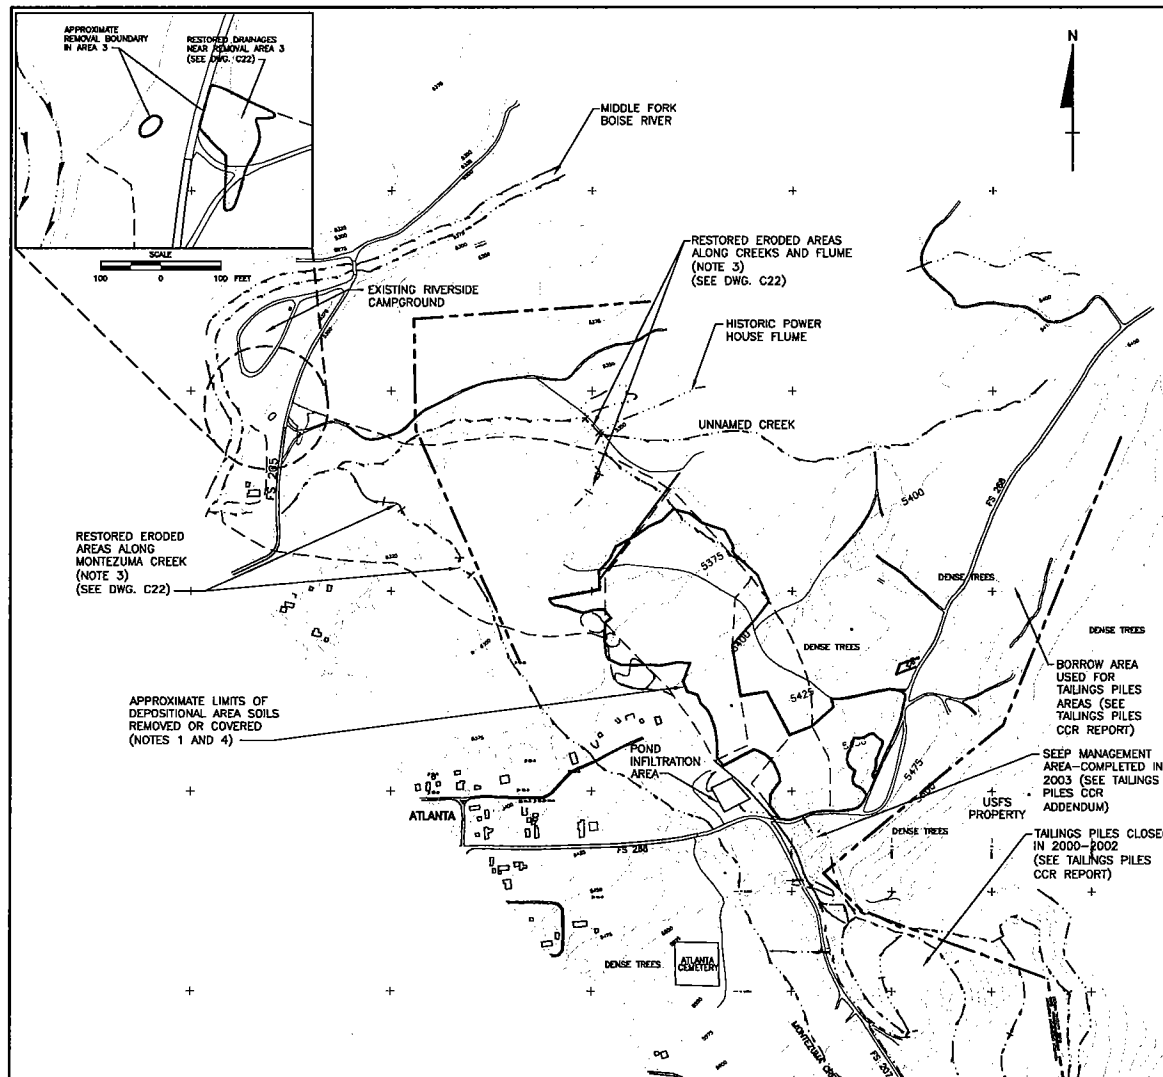
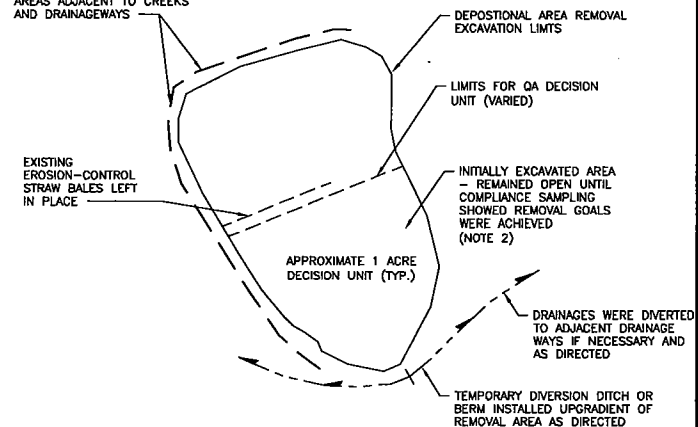
**ST. JOE MINERALS AND MONARCH GREENBACK**  
**TALACHE MINE TAILINGS PILES SITE**  
**DEPOSITIONAL AREA REMOVAL PLAN**  
 DATE MAY 2002 DWG. NO. 6240-C20 REVISION 4

1. APPROXIMATE LOCATIONS OF FEATURES AND DEPOSITIONAL AREA ARE SHOWN. LIMITS OF DEPOSITIONAL AREA REMOVALS WERE SURVEYED AND STAKED IN THE FIELD PRIOR TO CONSTRUCTION.
2. APPROXIMATE PROPERTY LINES ARE SHOWN. SEE FIGURE 1 FOR FINAL REMOVAL AREA BOUNDARIES WITH DECISION UNITS AND RELEVANT DATA. ONLY SEGMENTS RELEVANT TO REMOVAL ACTION ARE SHOWN.
3. ERODED AREAS ALONG POWER HOUSE FLUME AND MONTEZUMA CREEK WERE STAKED IN THE FIELD PRIOR TO CONSTRUCTION, RESTORED AND REVEGETATED. SEE DWG. C22.
4. TAILINGS WERE REMOVED FROM ACCESSIBLE AREAS IN THE DEPOSITIONAL AREA AS VISUALLY DETERMINED AND AS DIRECTED. AREAS WITHIN EXISTING TREES (LARGER THAN 4" DIA.), SOFT/WET AREAS OR OTHER AREAS NOT EASILY ACCESSIBLE HAVE A 6-INCH CLEAN SOIL COVER PLACED, AS DIRECTED.

TEMPORARY SILT FENCE OR STRAW BALES WERE INSTALLED ON DOWN GRADIENT SIDE OF REMOVAL AREAS ADJACENT TO CREEKS AND DRAINAGEWAYS

TYPICAL DEPOSITIONAL AREA REMOVAL PLAN  
 NOT TO SCALE

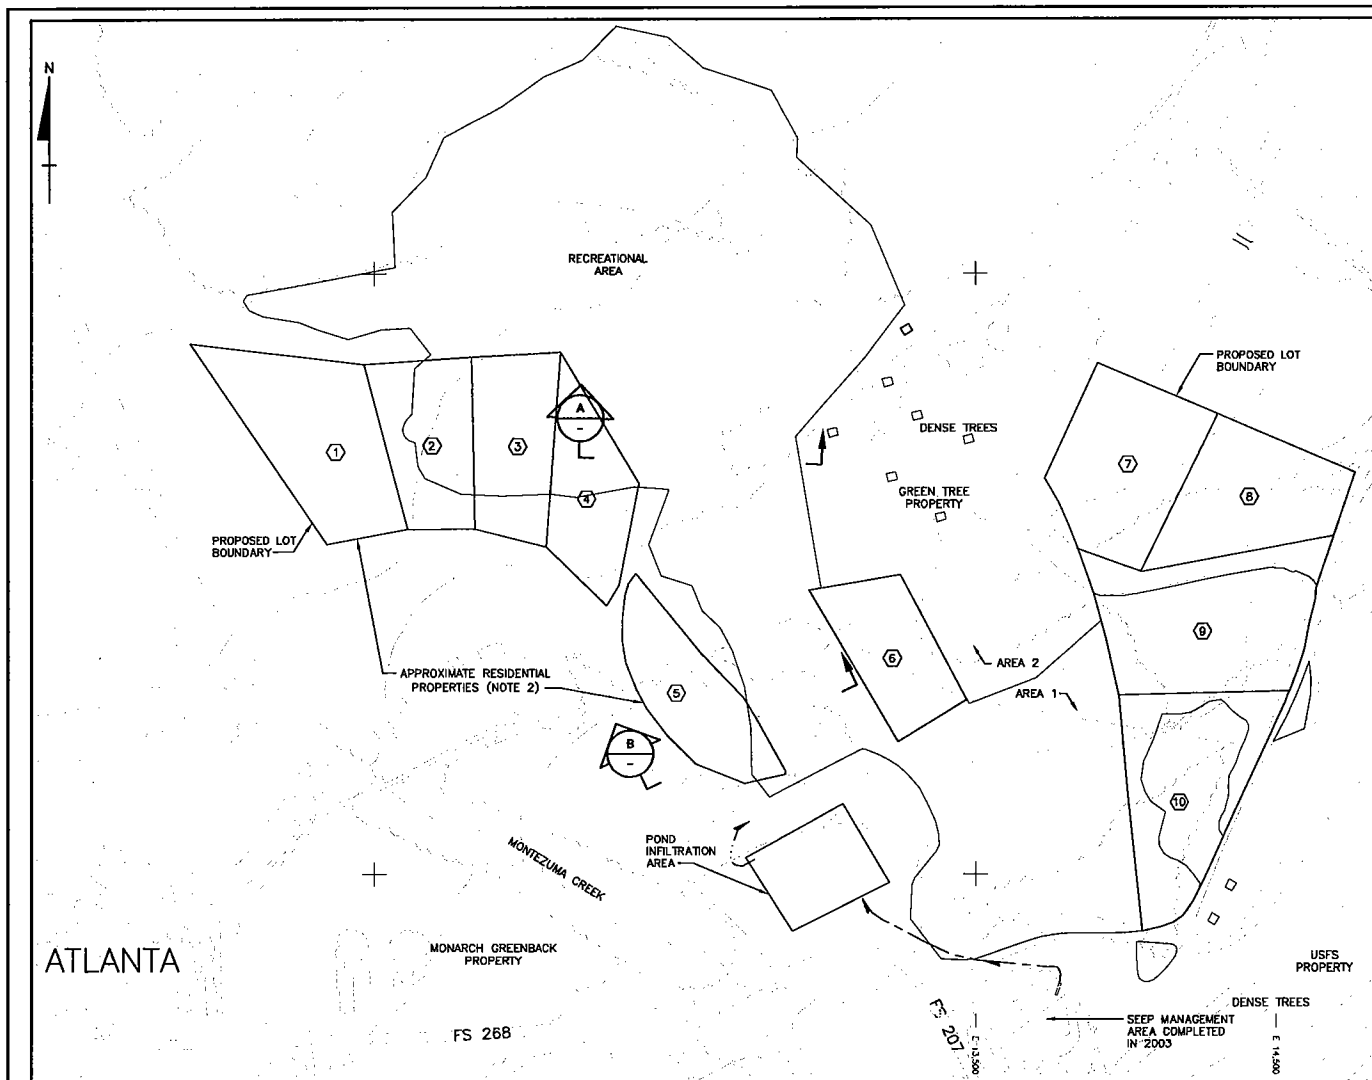
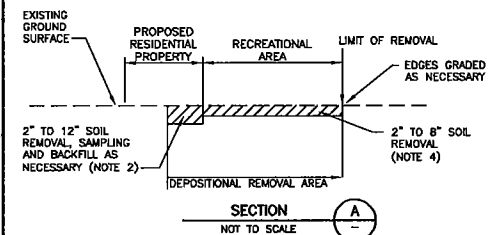
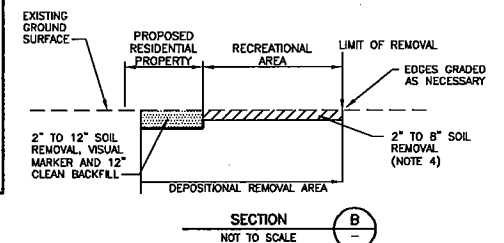
**ST. JOE MINERALS AND MONARCH GREENBACK  
TALACHE MINE TAILINGS PILES SITE  
DEPOSITIONAL AREA REMOVAL PLAN  
AT RESIDENTIAL AREAS**  
DATE: MAY 2002  
DWG. NO. 6240-C21  
REVISION 4

- APPROXIMATE PROPERTY LINES AND DEPOSITIONAL AREA REMOVALS WERE SURVEYED AND FIELD STAKED PRIOR TO CONSTRUCTION BY COMPANY'S REPRESENTATIVE. SEE FINAL HUBBLE SURVEY PLAN SHEET STK.
- VISUALLY IDENTIFIABLE TAILINGS WERE REMOVED FOLLOWED BY FIELD XRF SCREENING (NON-COMPLIANCE TESTING), ADDITIONAL REMOVALS AS NECESSARY.
- CLEAN BACKFILL WAS PLACED FOR DRAINAGE AS NEEDED FOLLOWING SUCCESS OF COMPLIANCE SAMPLING. IN THE EVENT COMPLIANCE SAMPLING WAS NOT SUCCESSFUL, A VISUAL MARKER WAS PLACED WITH 12-INCHES OF CLEAN BACKFILL.
- SEE FIGURE 1 FOR FINAL REMOVAL AREA BOUNDARIES WITH DECISION UNITS AND RELEVANT DATA.
- THE BURNED SLASH PILE AREA WAS SEEDED AND MULCHED IN 2003 AT THE DEPOSITIONAL AREA.

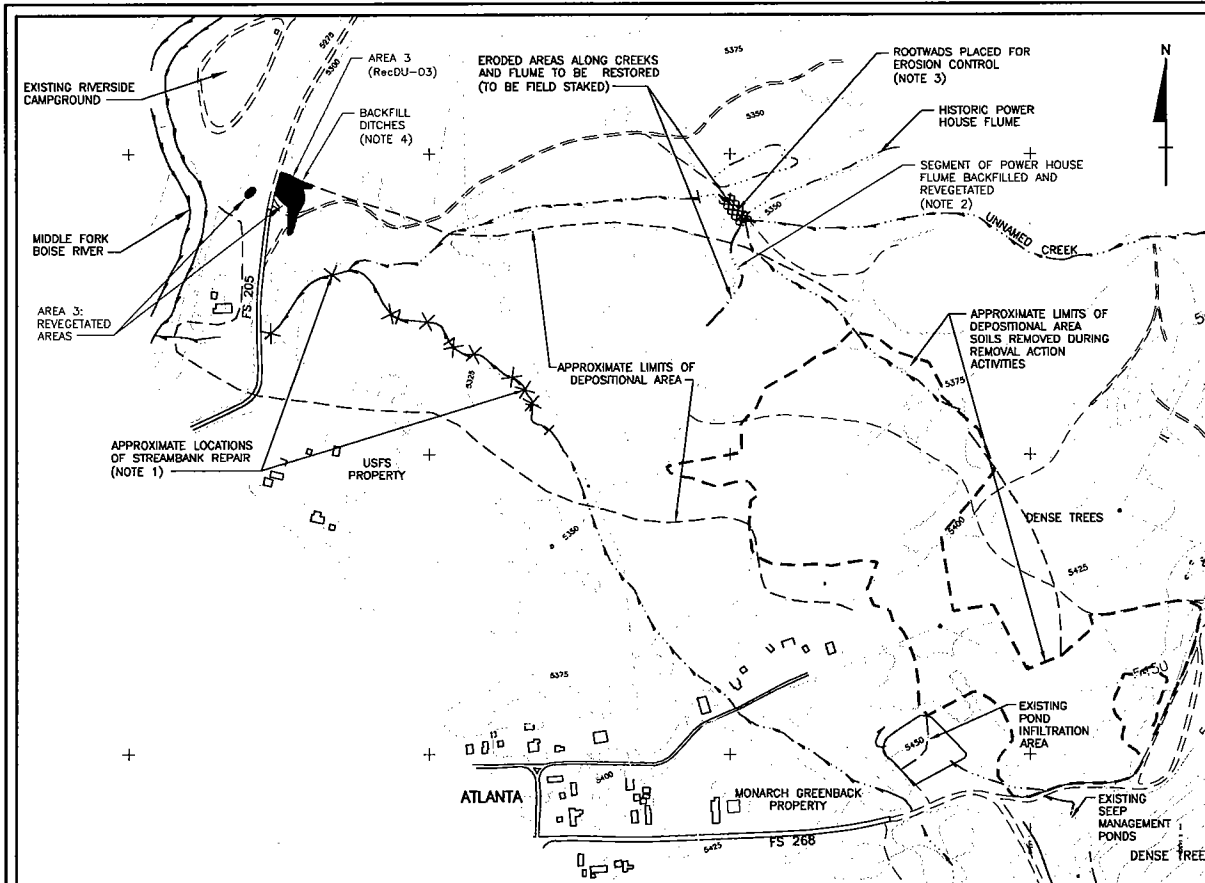
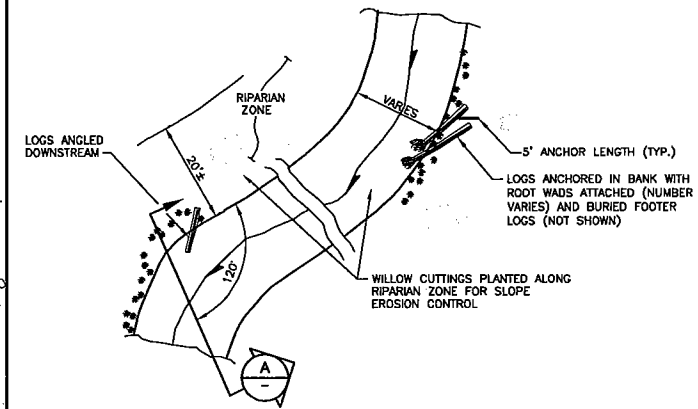
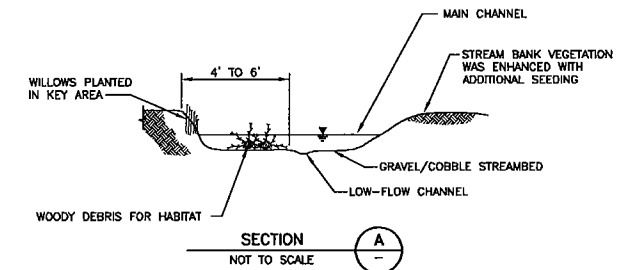
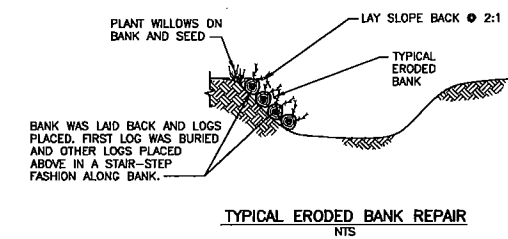
- NOTES:**
1. NINE ERODED AREAS ALONG STREAMBANK WERE REPAIRED AT LOCATIONS SHOWN. AREAS WERE IDENTIFIED AND STAKED IN THE FIELD IN CONSULTATION WITH EPA, REPAIRED AND REVEGETATED. TOTAL LINEAR CHANNEL LENGTH REPAIR  $\approx$  230'.
  2. A SEGMENT OF POWER HOUSE FLUME, APPROXIMATELY 500' IN LENGTH, WAS BACKFILLED WITH ORIGINALLY REMOVED SOIL AND REVEGETATED.
  3. APPROXIMATELY 12 ROOTWADS WERE PLACED AT THE ENTRY OF WETLAND (~8' WIDE).
  4. DITCHES IN AREA 3 WERE BACKFILLED WITH EXISTING BERM MATERIAL FROM PREVIOUS EXCAVATIONS.
